Report No. CETHA-BC-CR-90017

Task Order 2 Enhanced Preliminary Assessment

HAMILTON ARMY AIRFIELD
NOVATO, CALIFORNIA

January 1990

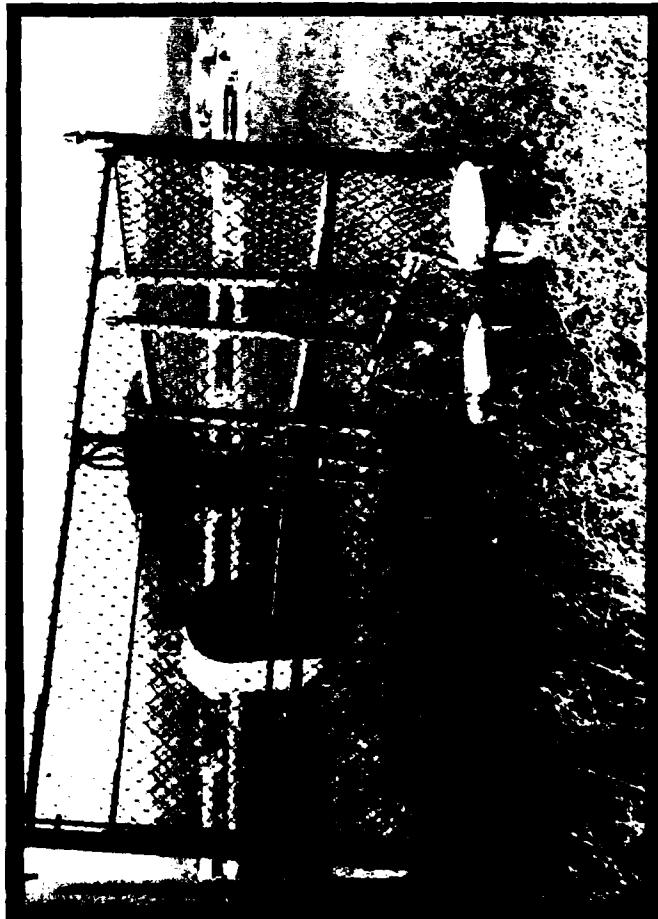
8. ABOVEGROUND STORAGE TANK
AT BUILDING 15
